## **2018 Operations, Maintenance, and Monitoring Report**

### **Bayou Chevee Shoreline Protection (PO-22)**

State Project Number PO-22  
Priority Project List 5

December 2018  
Orleans Parish

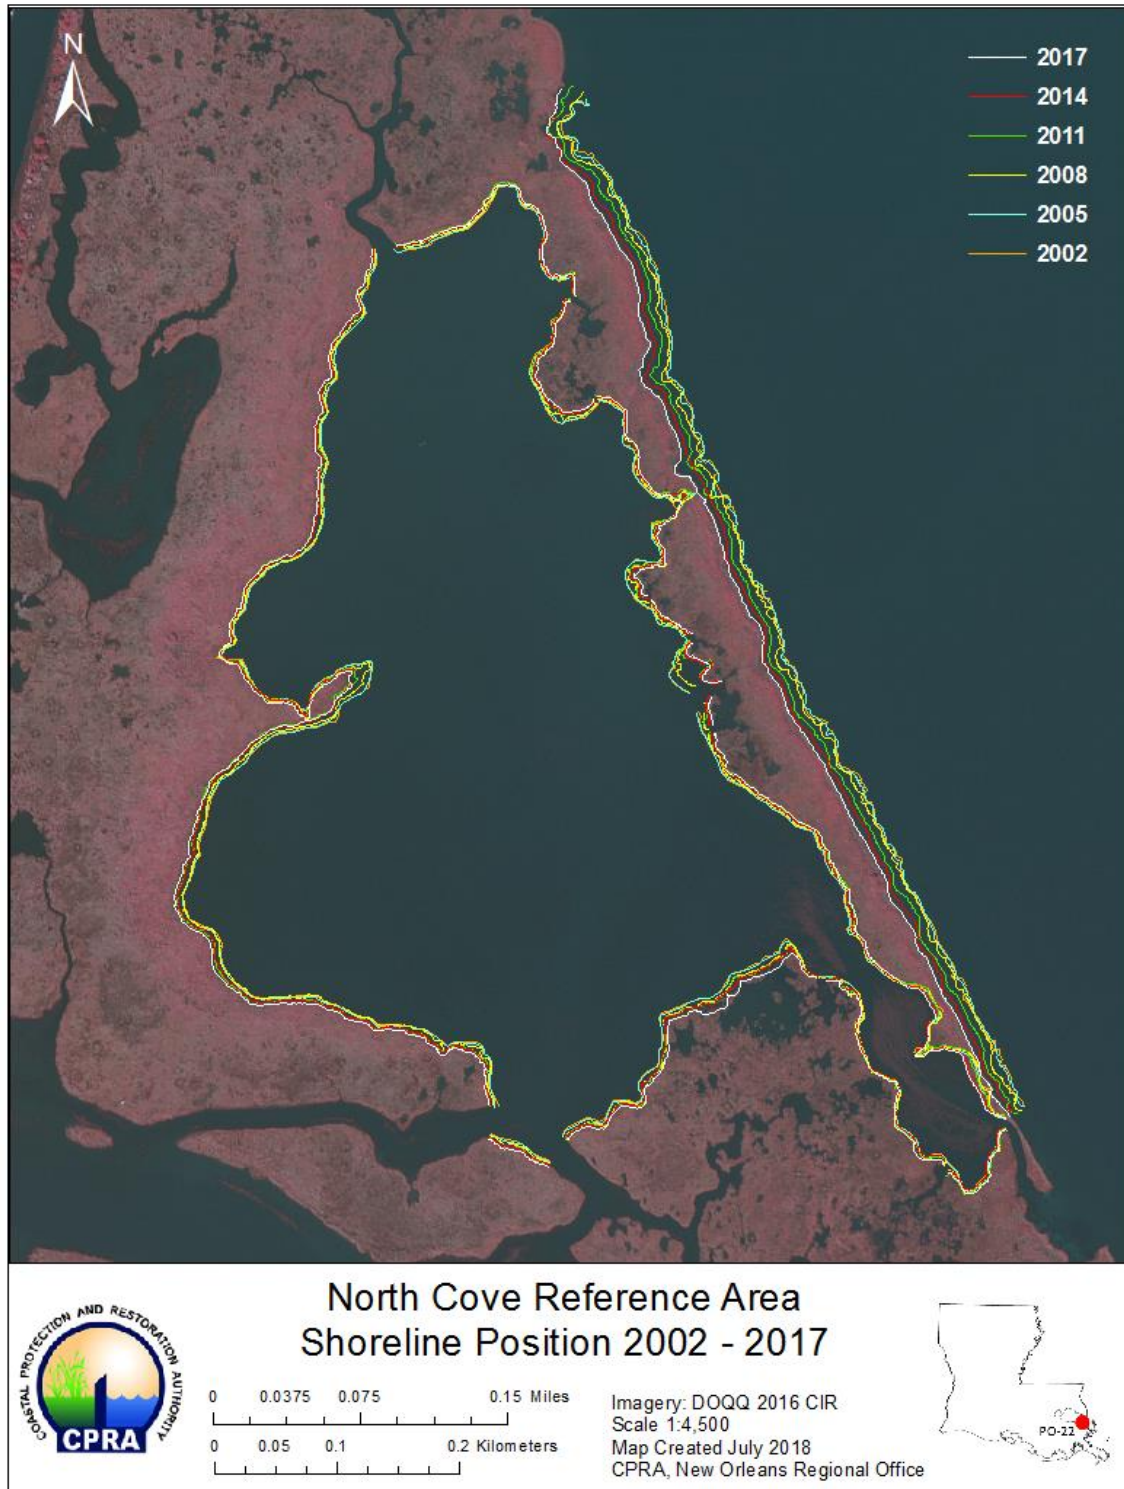
**Figure 4.** 2002, 2005, 2008, 2011, 2014, and 2017 shoreline position for the North Cove reference area of the Bayou Chevee Shoreline Protection (PO-22) project.

The North Cove reference area is divided into 2 sub-areas: 1.) an interior pond protected by a narrow strip of marsh from the wave action of Lake Pontchartrain, and 2.) a northeast-facing segment of Lake Pontchartrain shoreline (Figure 4). For the 2014 – 2017 time period the pond portion of the North Cove reference area experienced an average rate of shoreline retreat of 1.8 ft/yr (Table 1). The Lake Pontchartrain shoreline portion of the North Cove reference area experienced an average rate of shoreline retreat of 4.7 ft/yr (Table 1), and an average net shoreline loss of 13.5 ft (Table 2). The shoreline has retreated along the entire surveyed length of the Lake Pontchartrain shoreline at a fairly uniform rate. At some point between the 2008 and 2011 surveys, the narrow strip of marsh separating the interior pond from the lake breached at the southern end, just below southern extent of the surveyed area, creating a connection between the two. This breach does not appear to have expanded since then; however, there are several other locations north of the breach where the strip of marsh separating the interior pond from Lake Pontchartrain is approximately 40-ft wide and in danger of breaching in the near future (Figure 4).

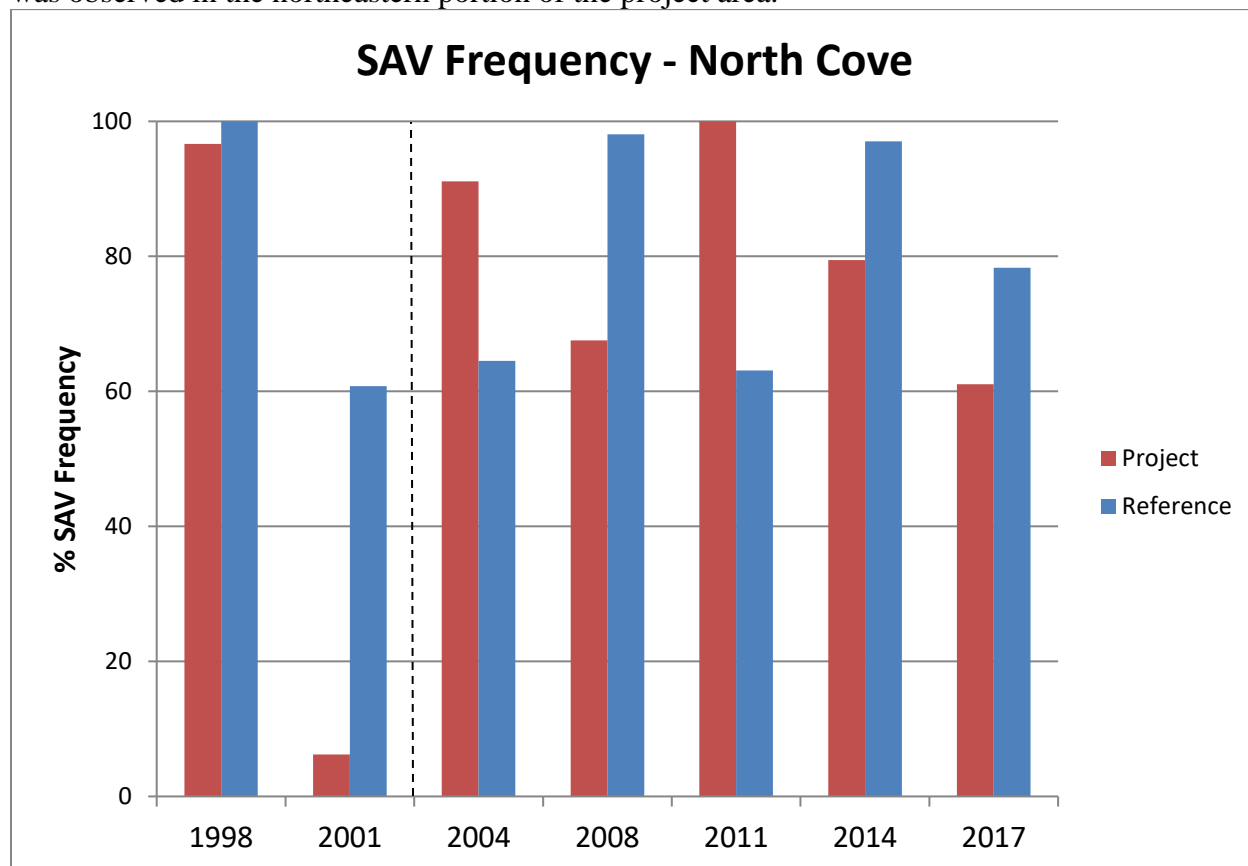
**Figure 6.** Frequency of occurrence of submerged aquatic vegetation (all species) in samples for North Cove project and reference areas for survey years 1998 – 2017 for the Bayou Chevee Shoreline Protection (PO-22) project. Dashed line indicates project construction.

The pre-construction surveys for overall SAV frequency for the North Cove showed inconsistent results. The project and reference areas showed very similar frequencies (96.8% and 100%, respectively) in the 1998 survey; however in 2001 SAV frequency in the project area had fallen to 6.2% versus 60.8% in the reference area (Figure 6). The post-construction surveys show higher SAV frequency in the project area in 2004 and 2011, with the 2008, 2014, and 2017 surveys showing higher frequency in the reference area. Post-construction surveys indicate greater similarity between project and reference areas. Mean SAV frequency was 79.8% in the project area and 80.2% in the reference area for the five post-construction surveys.

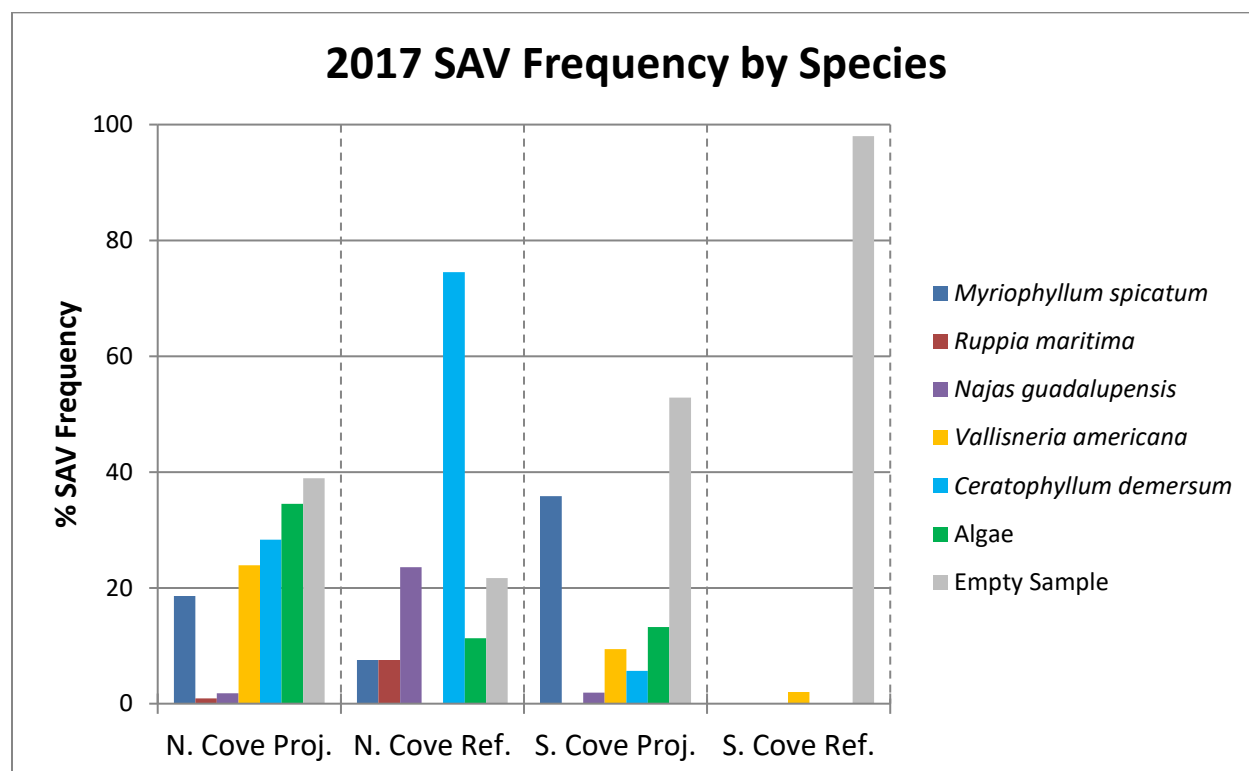
**Figure 7.** Frequency of occurrence of submerged aquatic vegetation in samples for North and South cove project and reference areas during the 2017 survey for Bayou Chevee Shoreline Protection (PO-22).

In the 2017 survey, coontail, *Ceratophyllum demersum*, was the dominant species in the North Cove project area (excluding filamentous algae; Figure 7, Table 3), as well as the reference area. Wigeongrass, *Ruppia maritima*, while present in both project and reference areas, was less abundant than previous years. Southern naiad, *Najas guadalupensis*, was present in both areas but much more abundant in the reference area than the project area. Similar to previous surveys eelgrass, *Vallisneria americana*, was observed in the project area but not the reference area. The relative frequency of eelgrass has increased in the 2 most recent surveys, and a large eelgrass bed was observed in the northeastern portion of the project area.

SAV frequency decreased in the South Cove Project area, from 86.8% in 2014 to 47.2% in 2017 (Figure 8). Although SAV frequency decreased, species diversity increased (Figure 7, Table 4). Similar to previous surveys, *Myriophyllum spicatum* was the most frequently observed species. *Najas guadalupensis* and *Ceratophyllum demersum* were also present, and *Vallisneria americana* was observed for the first time since 1998. The South Cove reference area was mostly devoid of SAV; 98.0% of samples contained no SAV. *Vallisneria americana*, present in 2.0% of samples, was the only species observed in the area.
